Ergonomic design of workplaces in atrium-type buildings

Piia Tint, Tarmo Koppel, Ada Traumann
The department of work environment and safety

Atrium-type buildings A, B, C,

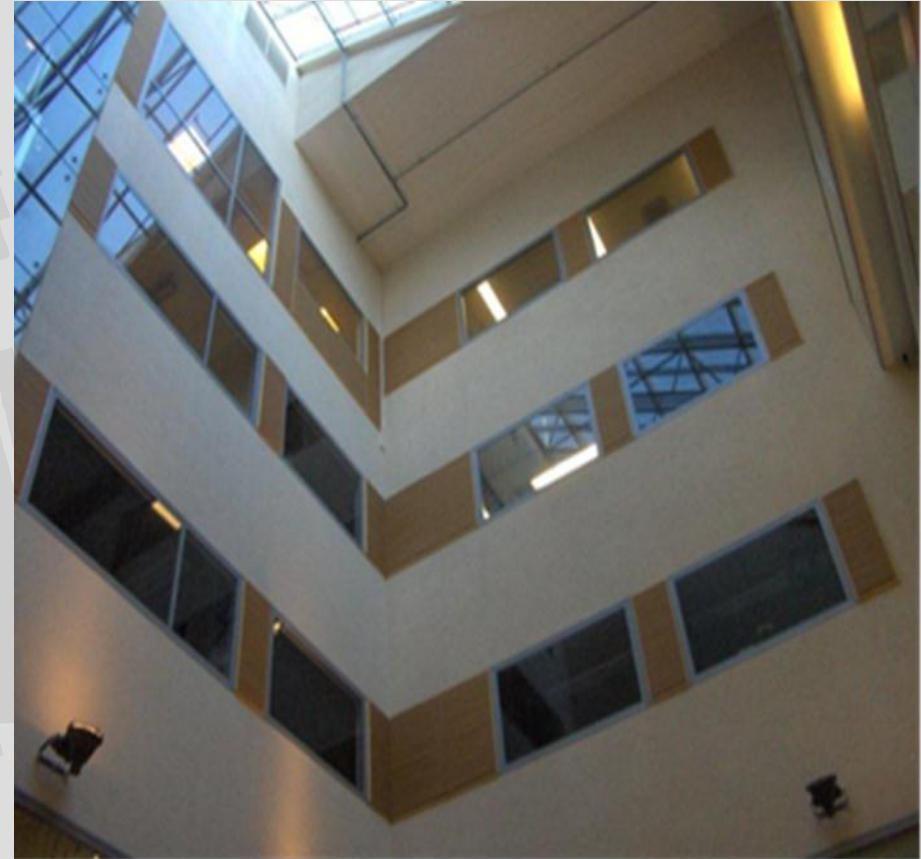
Building A

- built during period when the construction costs were very high (2003)
- the attention to the well-being at workers was not paid
- windows cannot be opened towards the atrium side
- the glass roof covers densely the atrium
- access to natural light is possible only from the 4th floor

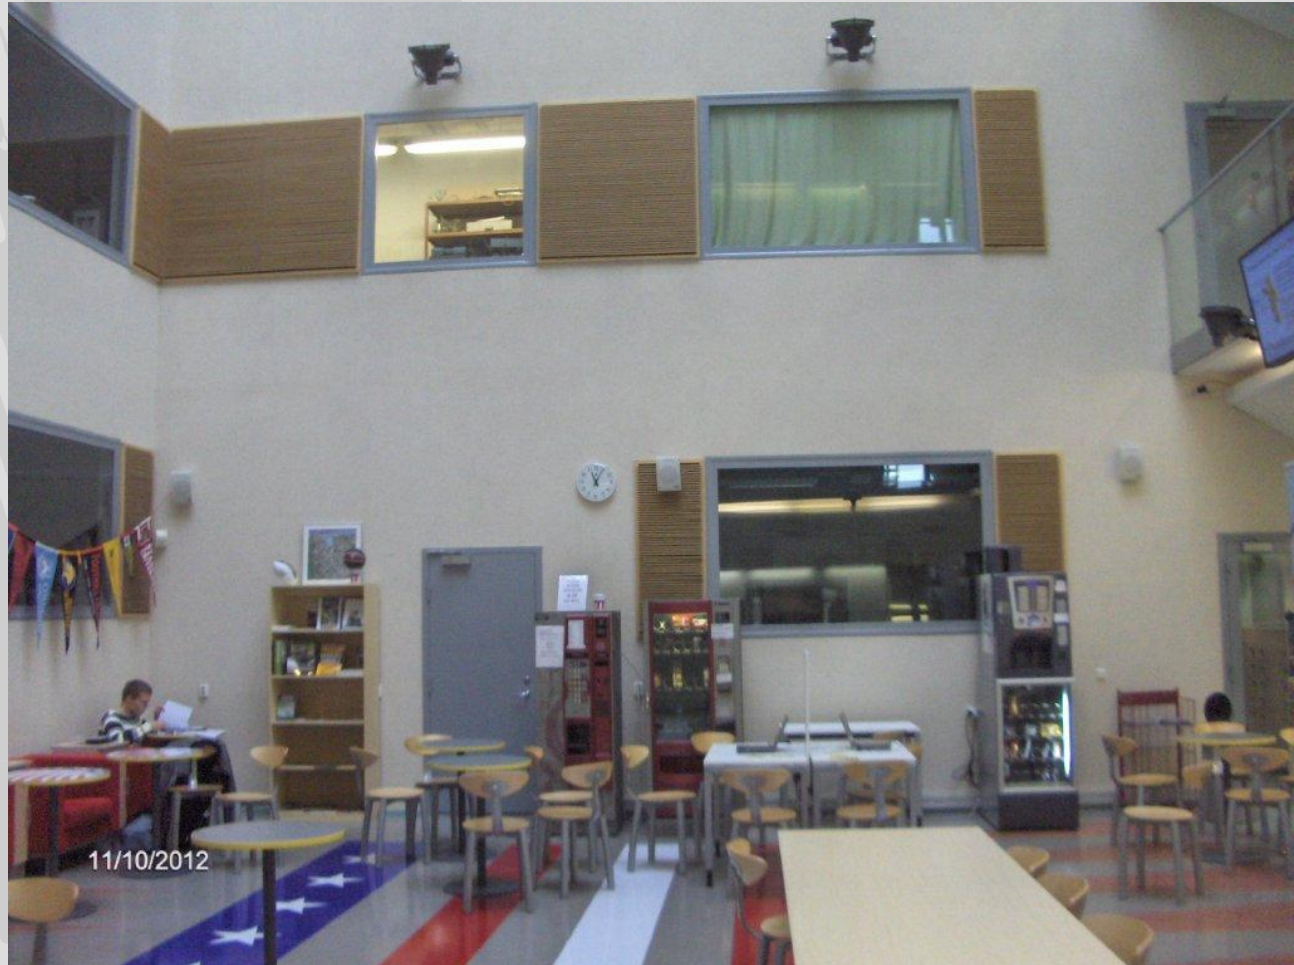
Building A- atrium with closed glass roof

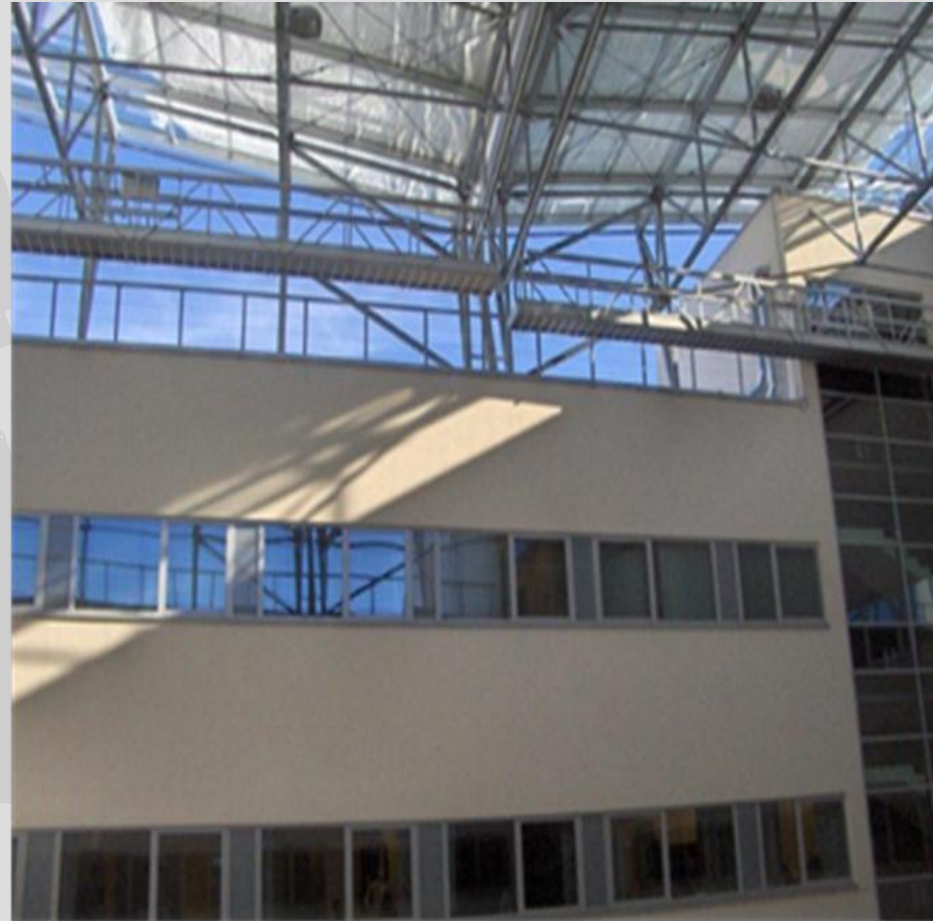
Building B

- The house built during period when construction cost were low (2009)
- windows close to the atrium could be opened
- the roof is covered with glass but there is a slope between the roof and the wall
- natural light accesses only upper floors (4 storeyed house)

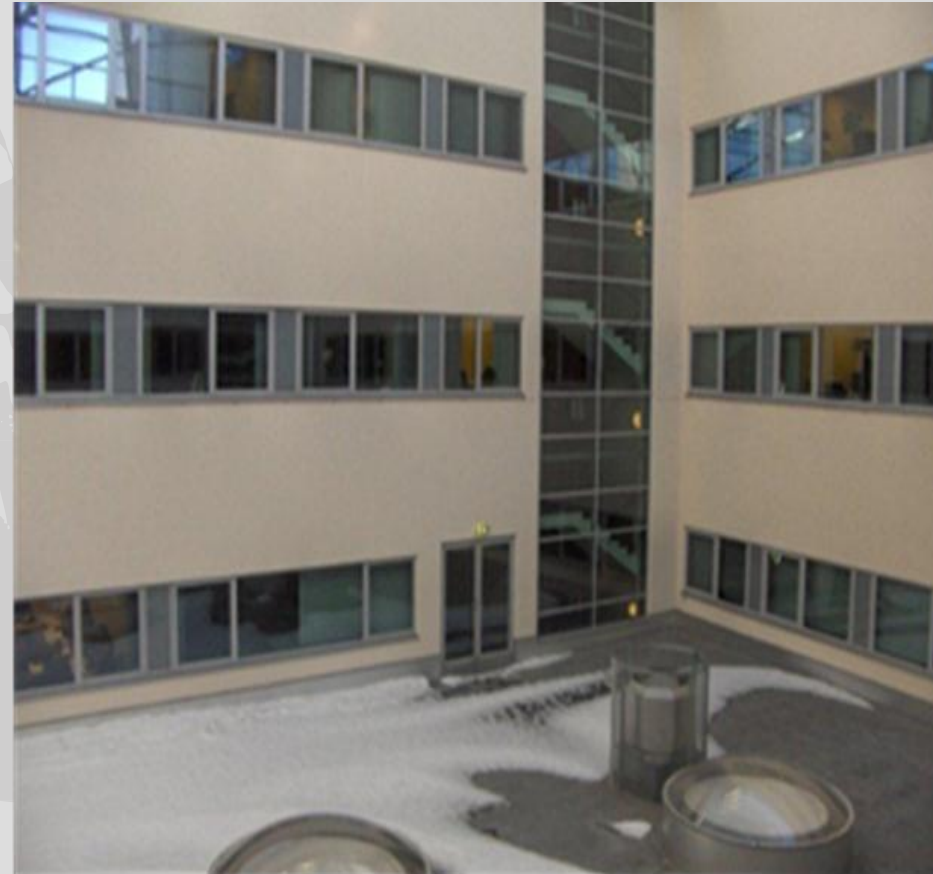
Building B problems

- wet climate of nordic countries
- windows of the first floor are too low
- moistered work rooms
- development of mycobacterium

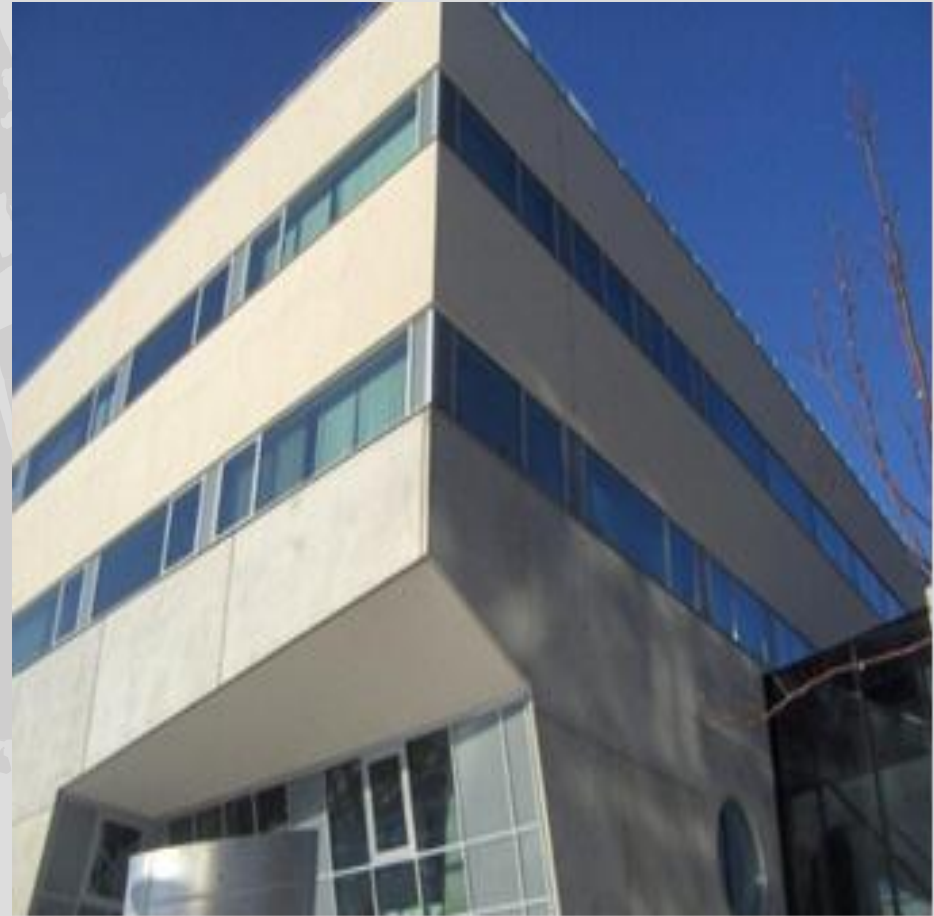
Building B problems

- low temperature in cold season
- high temperature in warm season

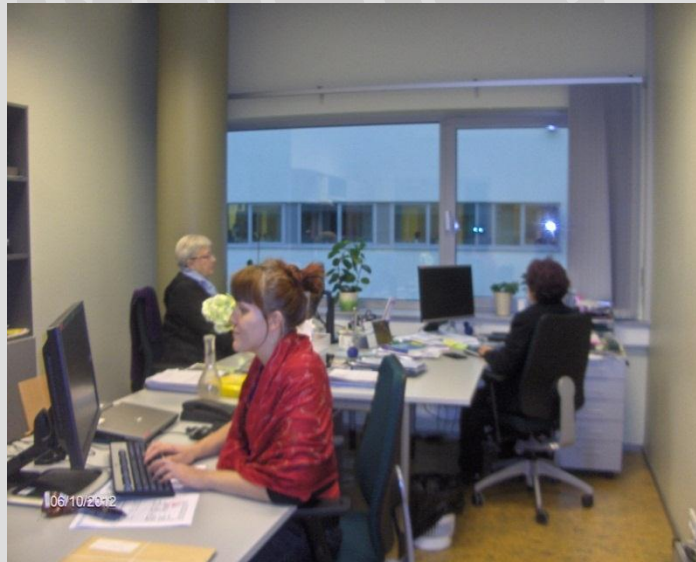
Building B,

slope between the roof and walls; fresh air, cold rooms

- wet climate of nordic countries
- windows of the ground floor are too low
- natural lighting in the rooms with computer workplaces is not sufficient
- the workers and workplaces from the other side of the atrium are disturbing factor for the workers working in the room showed in the photo

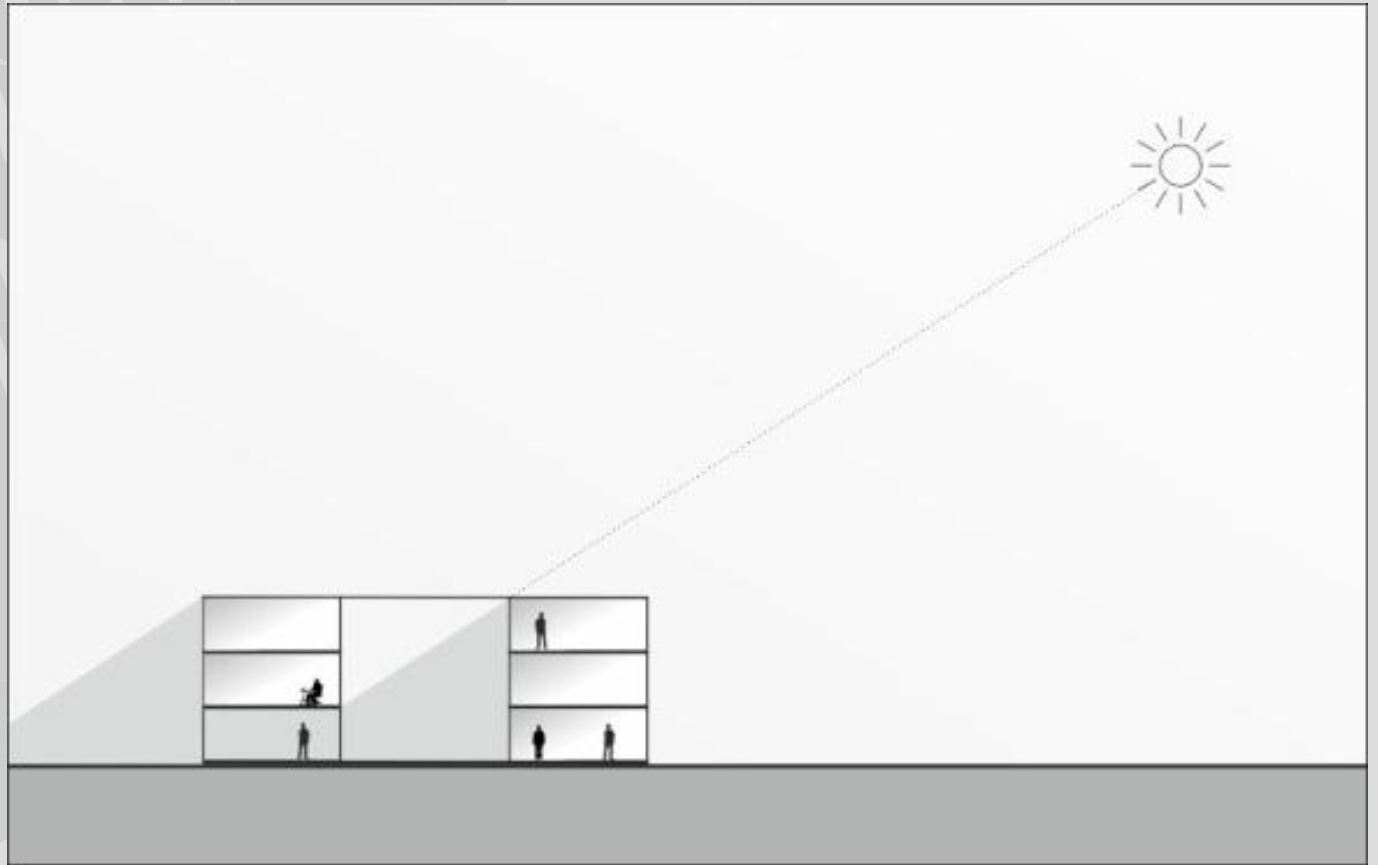
Building C in 2010, Lighting conditions in 3-storeyed building good

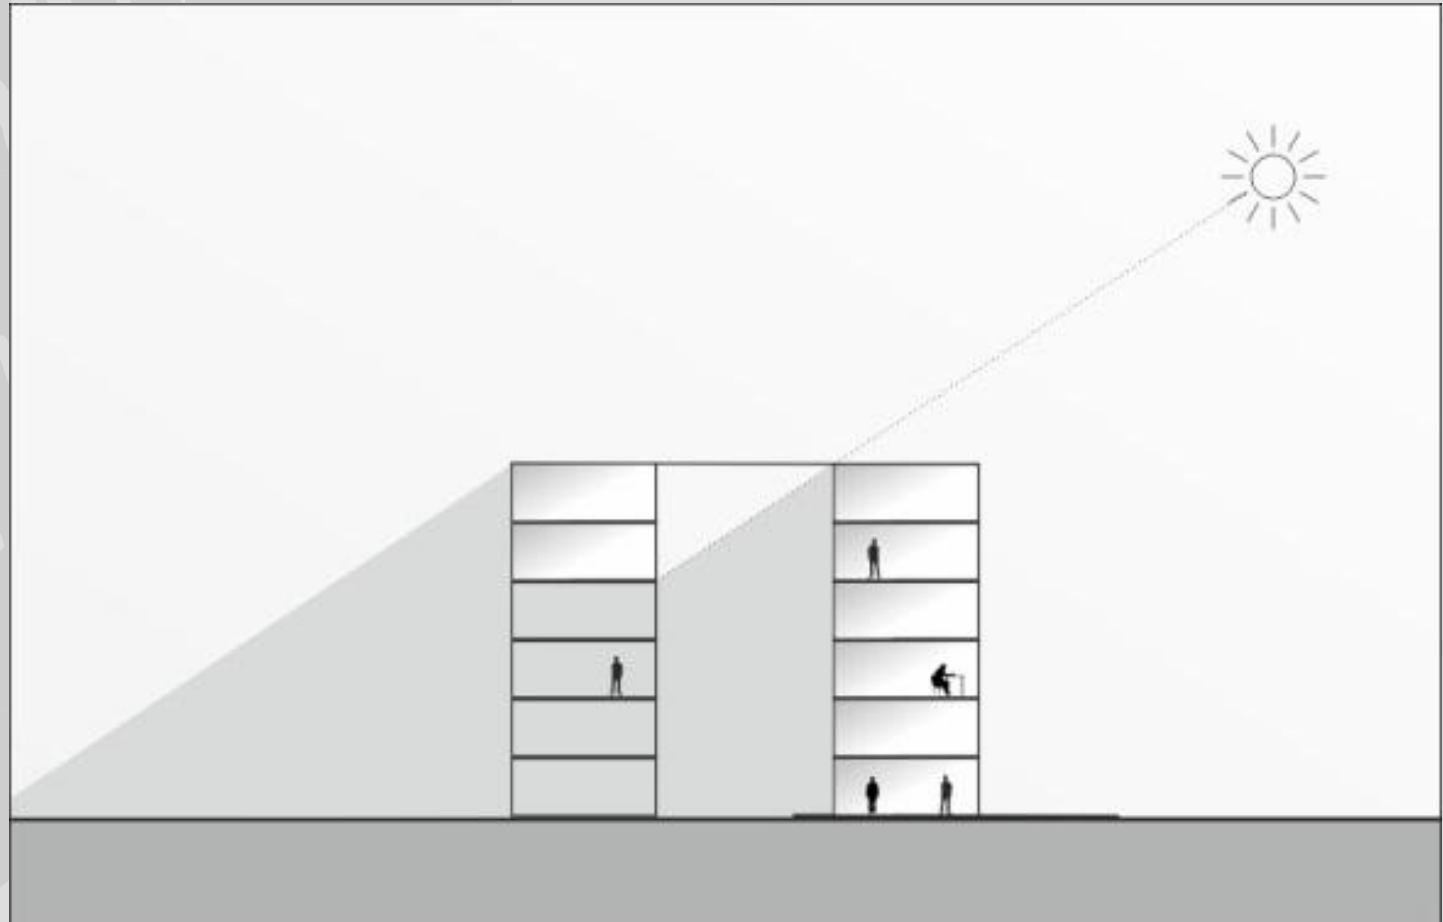
Building C in 2012 (6 storeyed)

Lighting conditions worsened

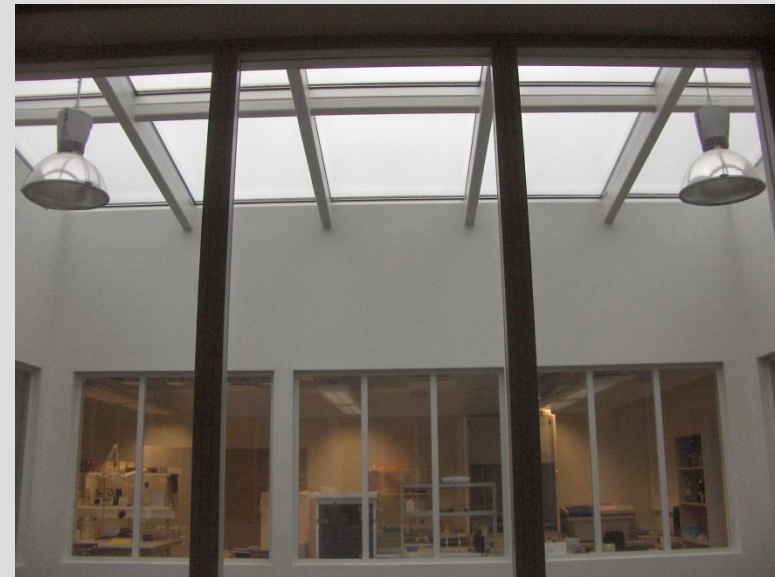
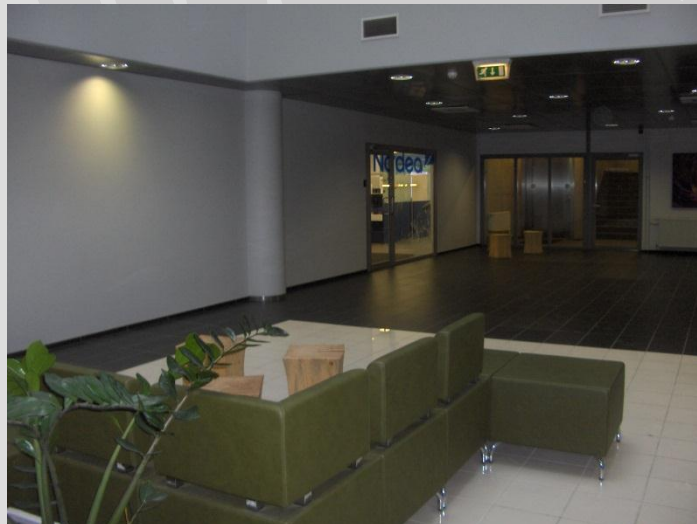
Building C,

Closed atrium
Good working conditions in
the 1 and 2nd floor

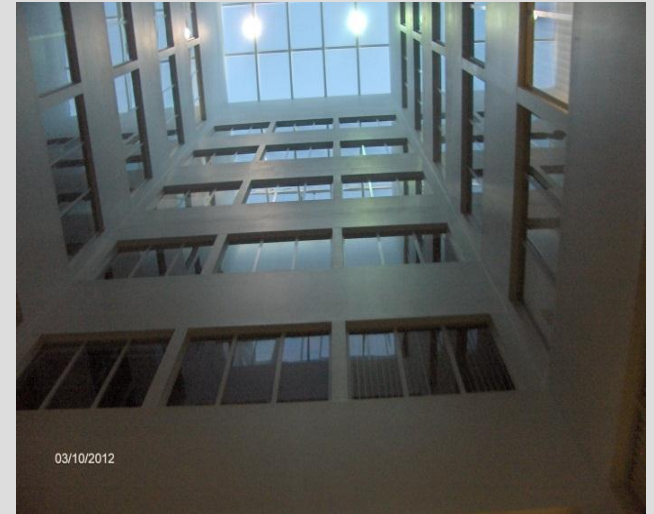
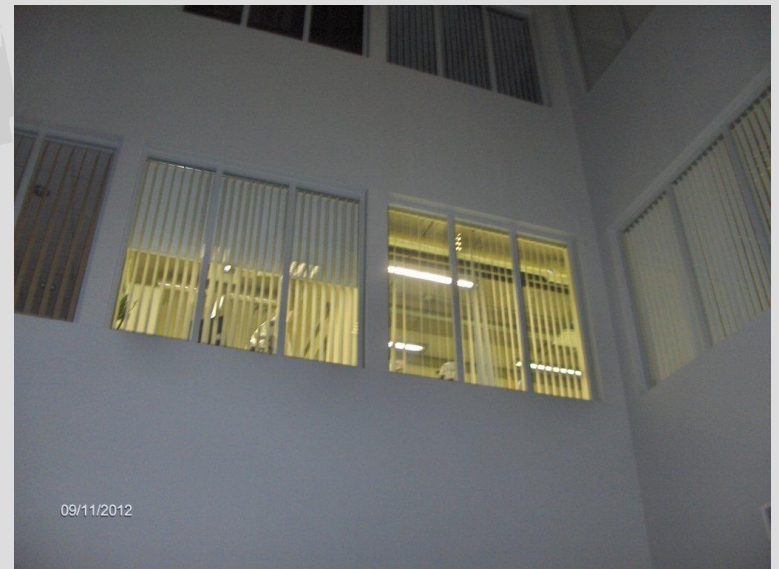
Building C, 6 storey

3 storeys were added to
the 3-storeyed house in
2012

The working conditions
worsened in the 1-2
floors.

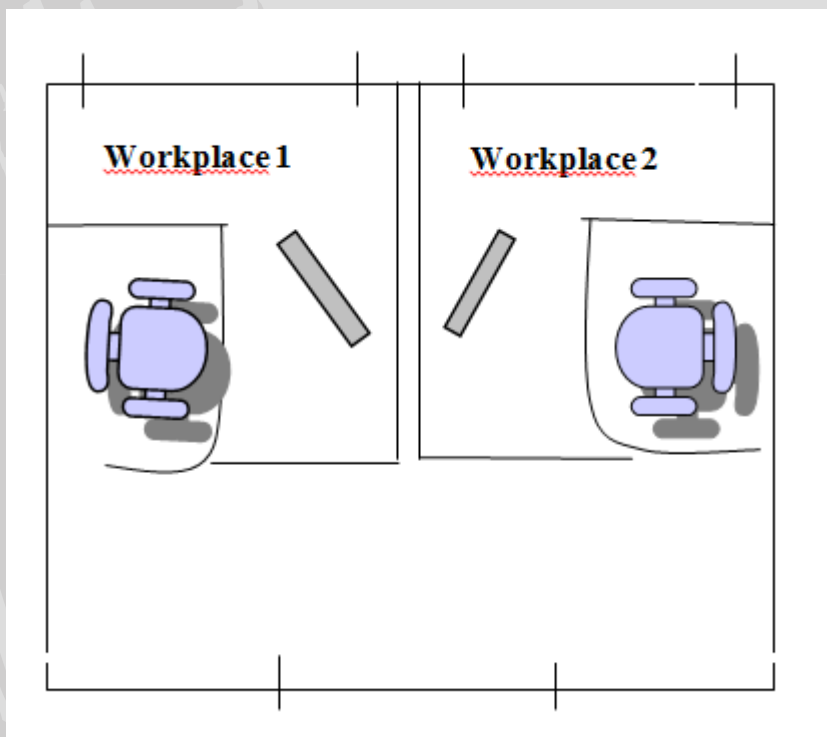
Current placement of workplaces

- Shortages:
- The workers are looking at each other (psychological stress factor)
- The place for chair is very tight
- The workers cannot open the window

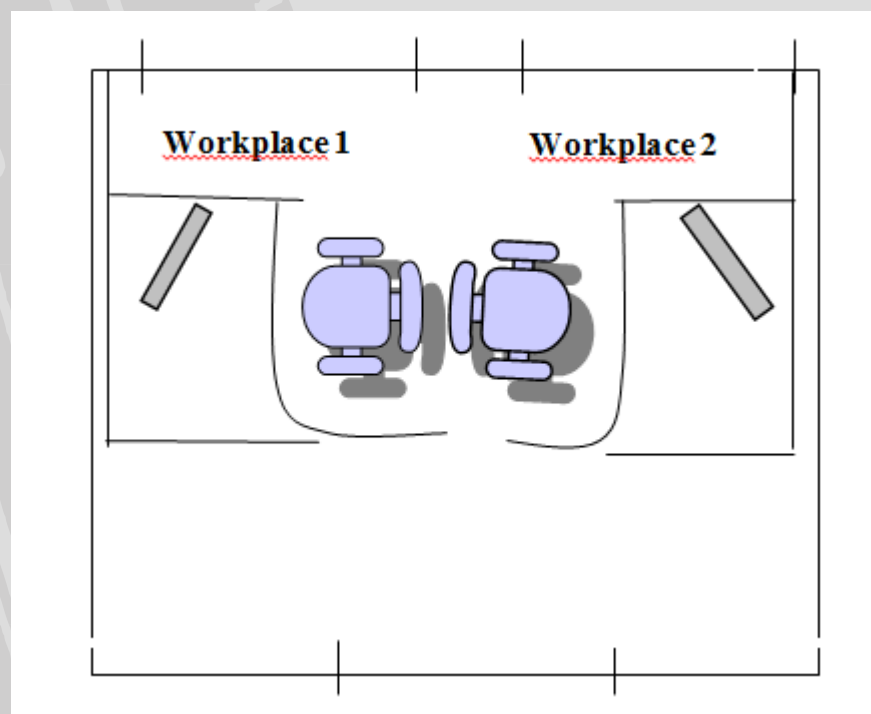
- Shortages:
- The chairs could hit each other
- Advancements:
- If only 1 worker is in the workplace, then the conditions are better (for the worker 2 particularly)

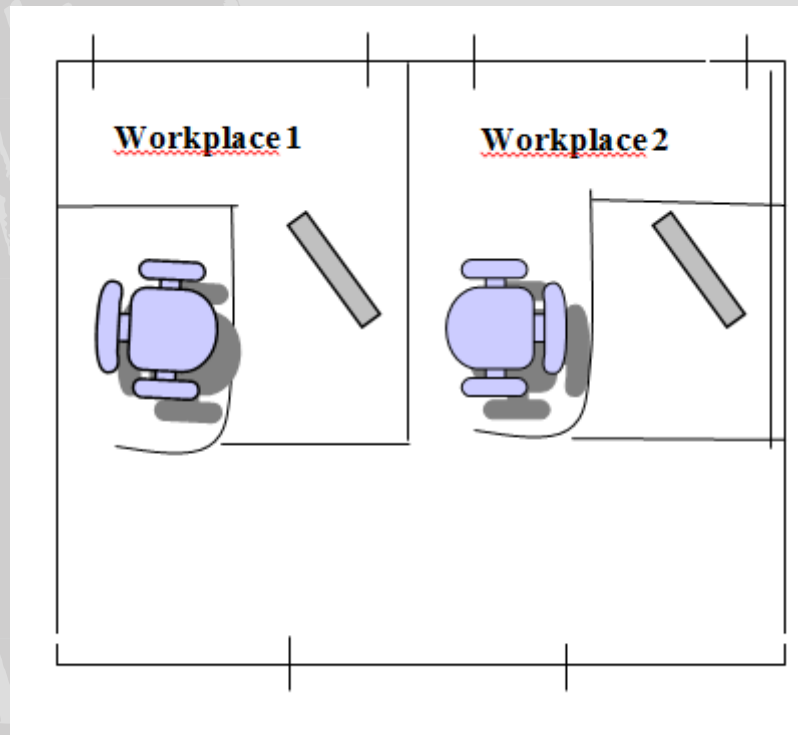
- Shortages:
- the worker in workplace 1 can follow the monitor of worker number 2
- Advancements:
- The natural light is coming from the left side to the worker
- There is a possibility to open the window
